STEVEN L. MARESCA

November 23, 2011

Moriches–Mastic–Shirley Community Library
407 William Floyd Parkway
Shirley, N.Y. 11967
attn: Kerri Rosalia

Re: Structural Inspection
Main Library Building

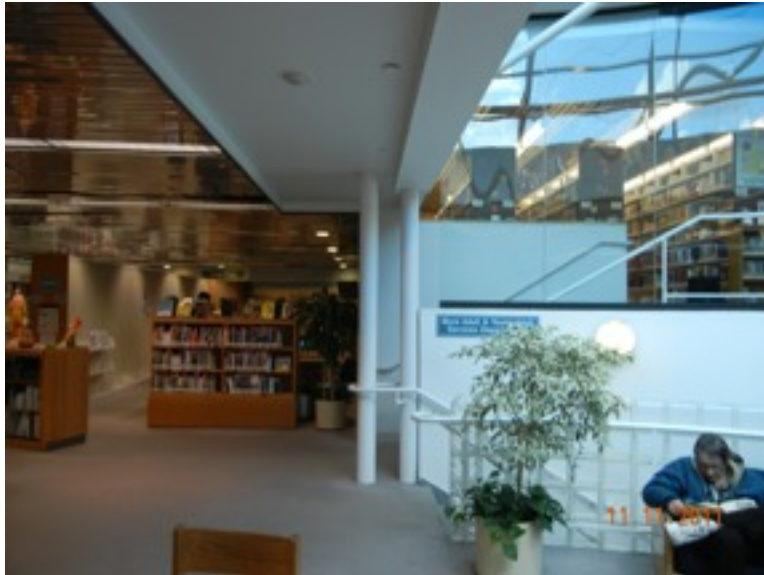
2. The main columns supporting the structure at the location of the interior skylite appear to be bent. This may be inherent in the columns since they were installed or due to overloading. The columns and steel above them should be fully exposed and measured for straightness. From the drawing that I have reviewed, there was a column removed from the original structure. It could be that the remaining columns are not sufficient for the new loads. If overloaded, they pose a serious structural problem.

View of the steel columns at the transition between the old and the new building. I was able to detect some curvature on the old column. This will need to be measured to verify.

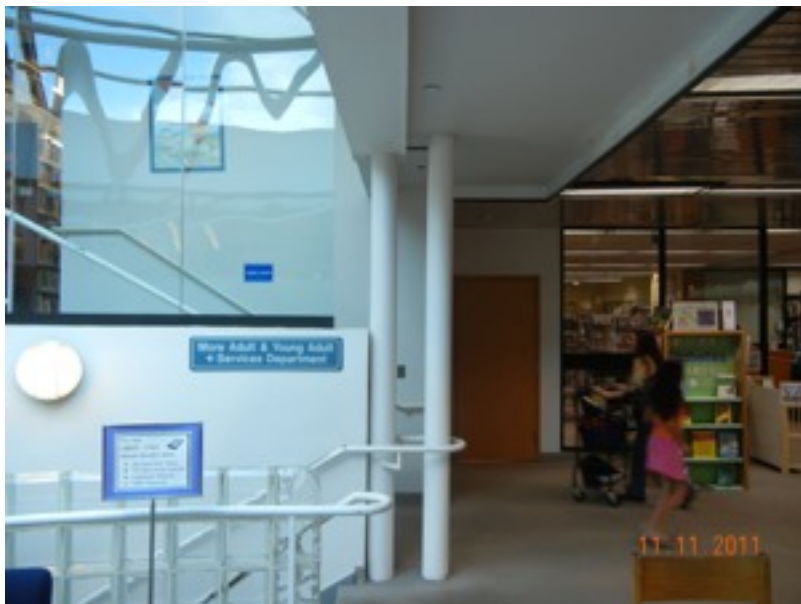
View of the column on the opposite side. This column also appeared to be curved. The curvature could be from over loading or could be built into the column from day one. The steel will need to be exposed and measured.

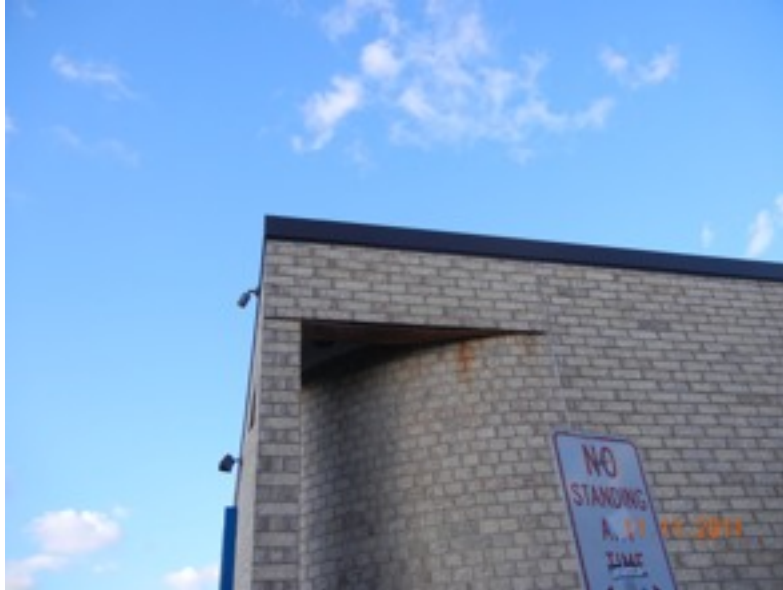
1. The steel lintels that support the exterior masonry walls have an excessive amount of corrosion. Several of the lintels need to be dealt with immediately. They may pose a danger. It appears that the steel was never properly painted and no weep holes in the masonry were supplied.. The masonry above the lintel will need to be removed to expose the steel for inspection. The existing steel may be saved. The lintel sections will need to be cleaned and painted at a minimum. The masonry then replaced with the proper weep holes.

View of a steel lintel at the southwest corner of building. The steel is badly corroded.

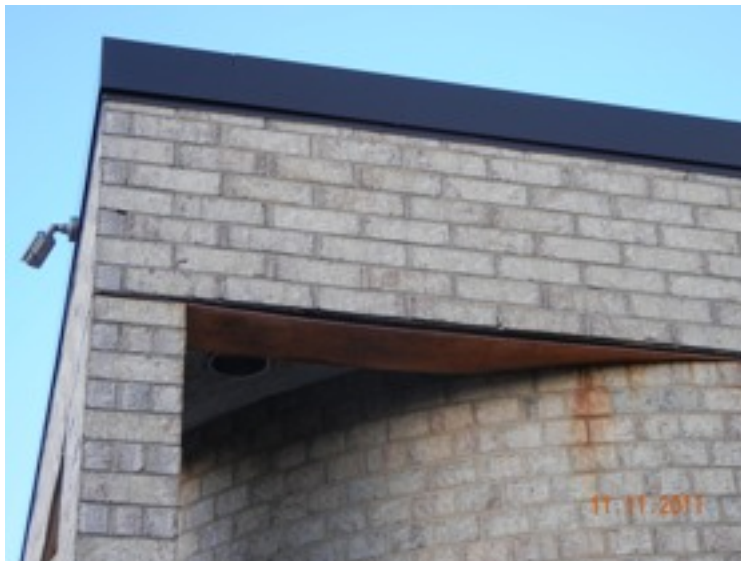
This is a closer look at the steel lintel. Note how the steel has pulled away from the masonry. It appears that this lintel has lost much of its strength. The bottom steel plate that we see could be pulled away from the steel frame above.

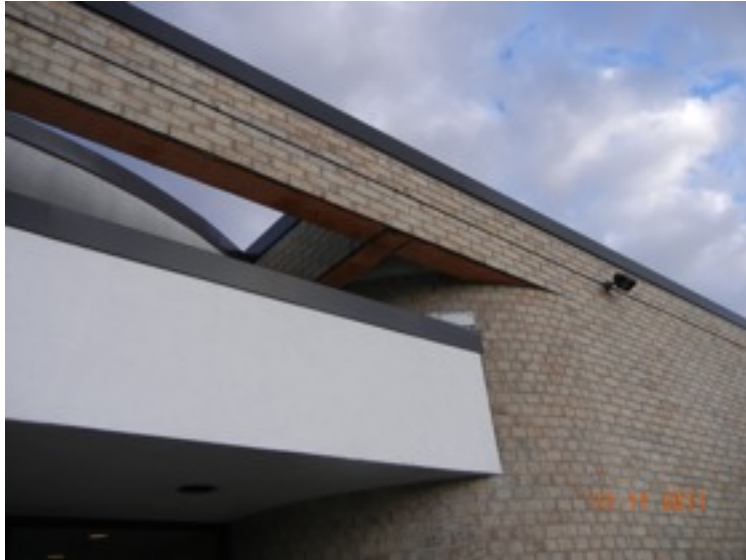
View of the steel lintel over the main entry. In this case there is a steel girder cantilevered out from the main building. Much of the steel is corroded.

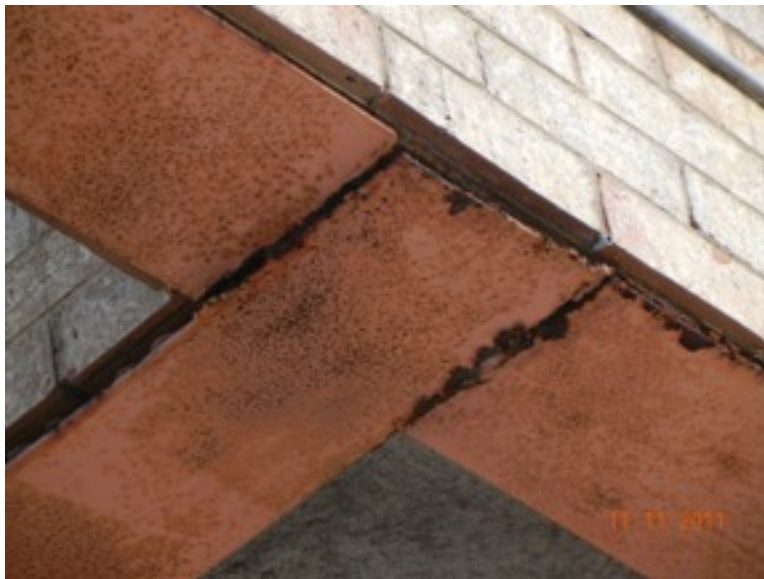
Closer view of the steel connection with the cantilevered girder. Note that much of the corrosion is above the steel, behind the masonry. The masonry will need to be removed to expose all of the steel.

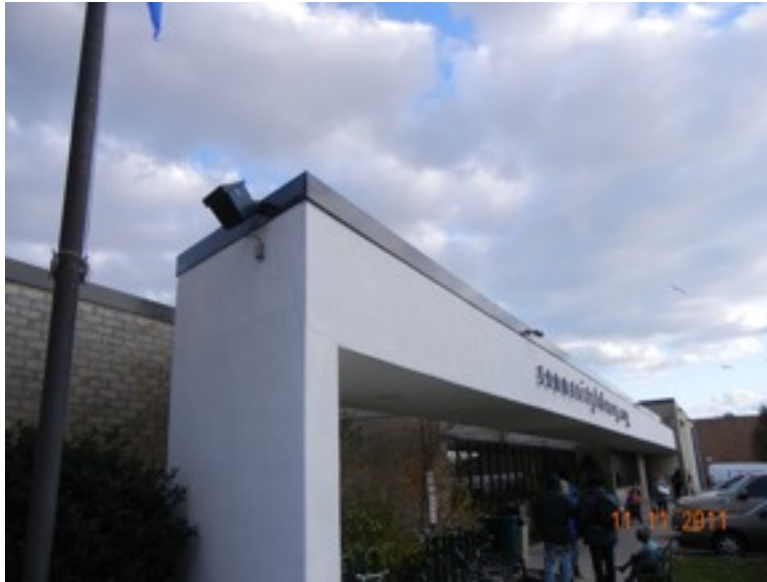
View of the front awning. I was able to note cracks at the intersection of the awning and supporting end wall.

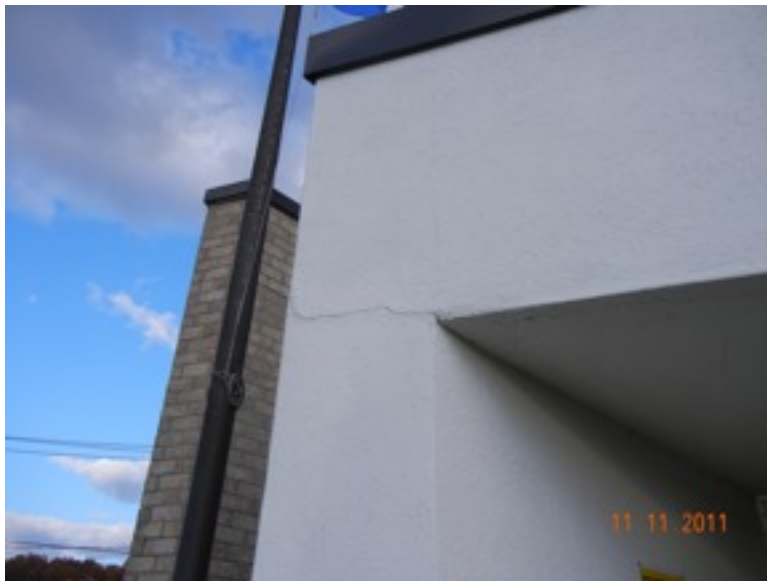
Closer view of the cracks in the finish. The finish should be exposed to determine the cause of the cracking.

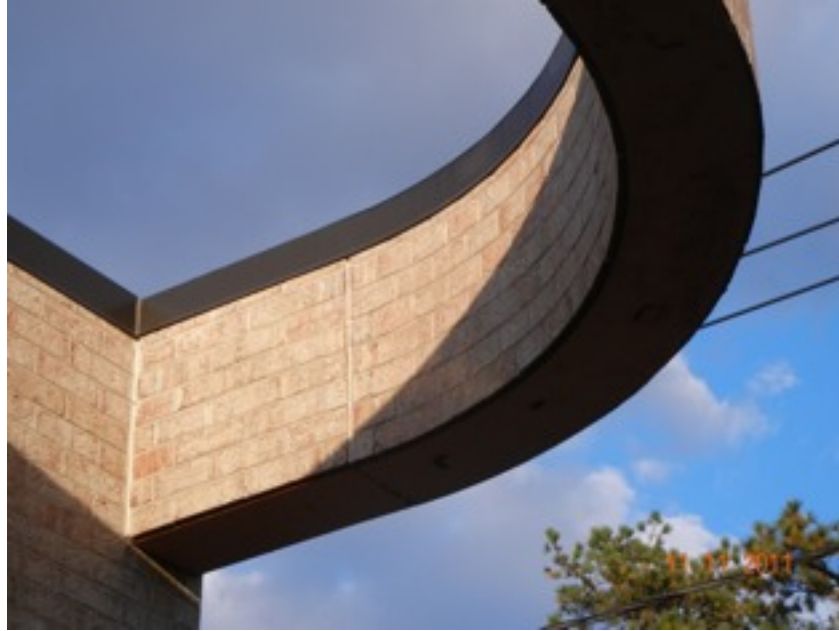
View of a curved header at the rear of the building. There is corrosion of the steel along the length of the header.

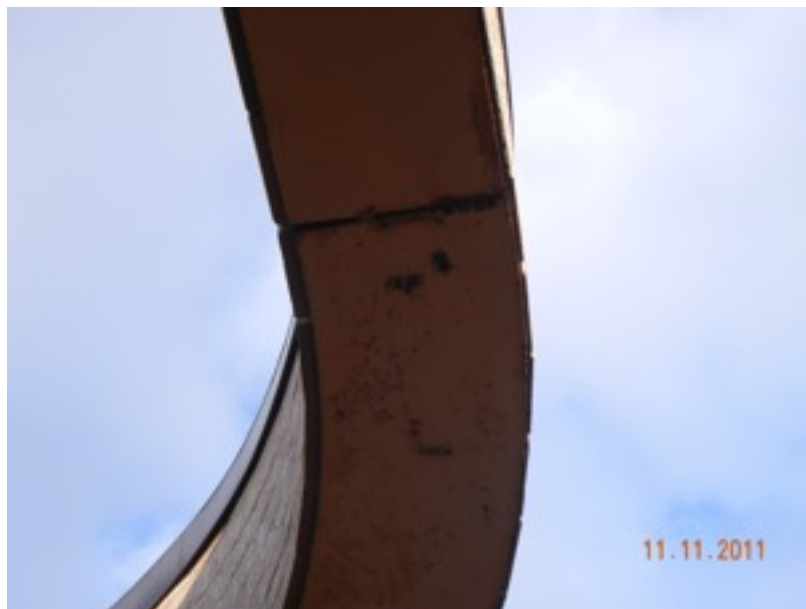
Closer view of the curved header. There is a steel connection along the length of the lintel. The masonry will need to be removed to inspect, clean and paint the steel.

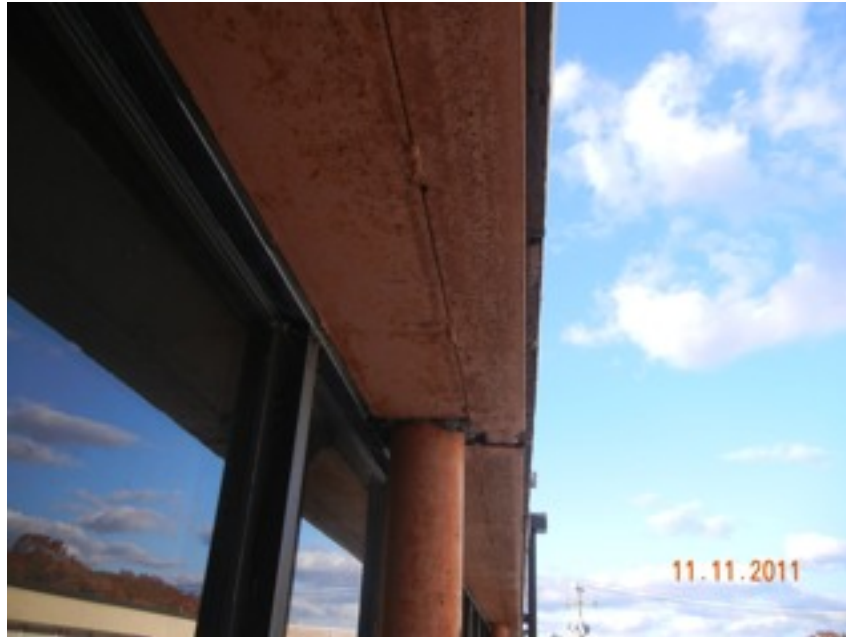
View of exterior steel lintels at clerestory windows in the original structure. The steel will require cleaning and painting.

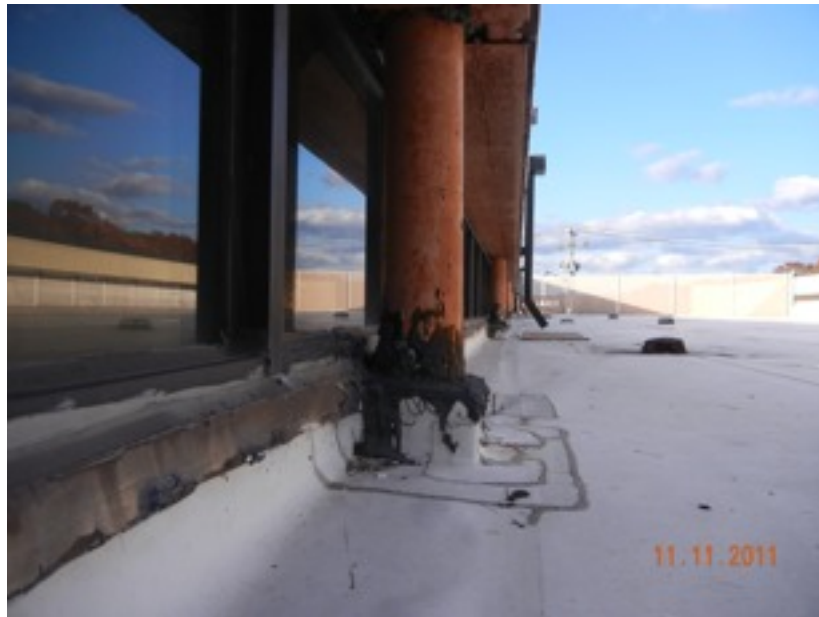
1. Steel columns that protrude above the roofing membrane show signs of past water leakage and rust. They will need to be cleaned, painted. The roof penetration may require new flashing.
2. The majority of the steel frame, directly below the columns, will require minor cleaning and paint touch up at the connection. There is no lose of steel section nor connection capacity.

View of the lower sections of the same columns. We were able to note leaks below many of these columns. The columns should be cleaned, painted and reflashed if the leaks are active.

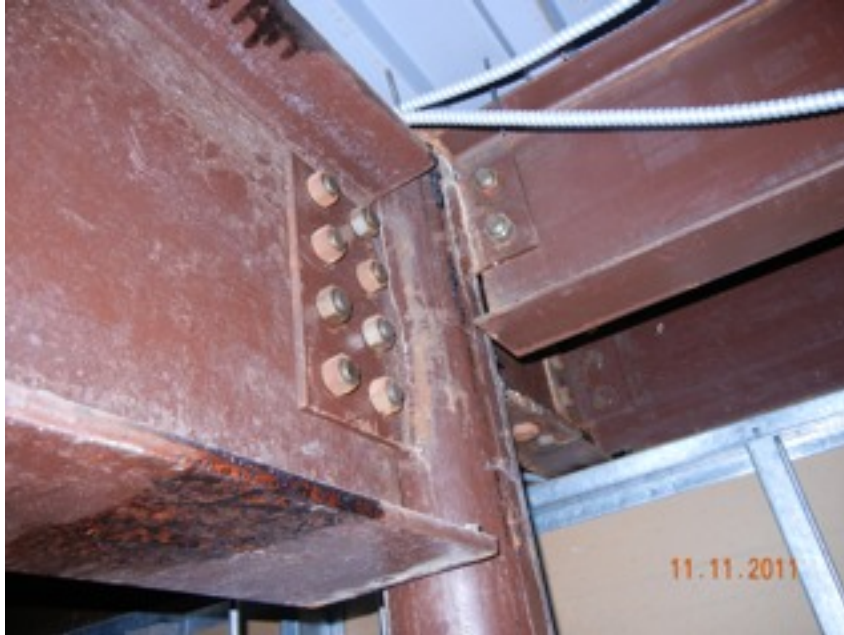
View of a main steel girder in the original structure. We noted water staining in the ceiling below. The water is a result of the roof leakage previously noted. There were no signs of steel corrosion. Only a minor clean up and painting will be required.

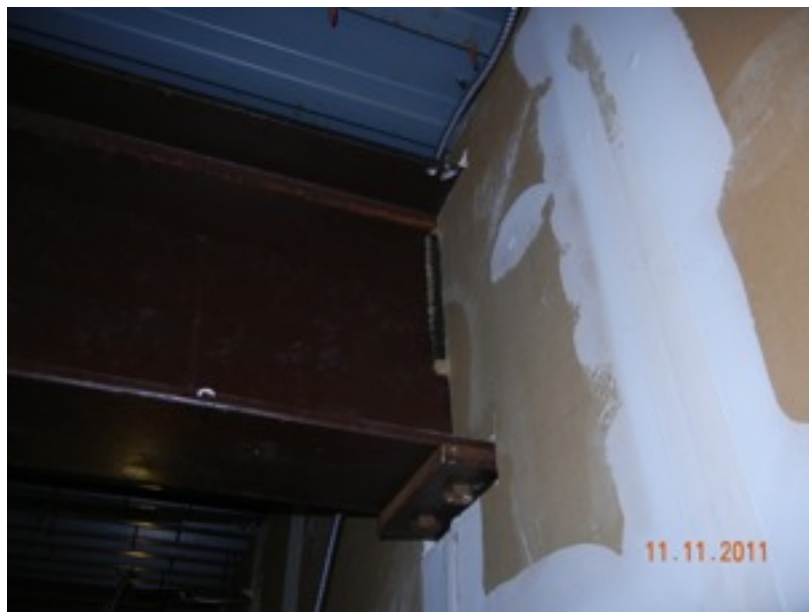
View of steel girder that cantilevers out past the front wall. There were no signs of corrosion.

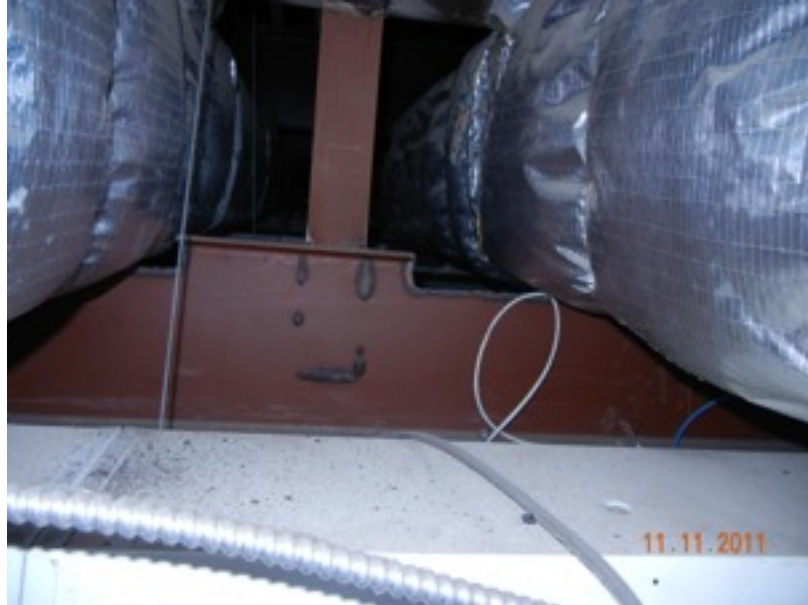
View of steel hangers in the newer portion of the building. The cut steel is not of concern. It appears that the hangers are only meant to support the HVAC ducting and a movable wall partition below.

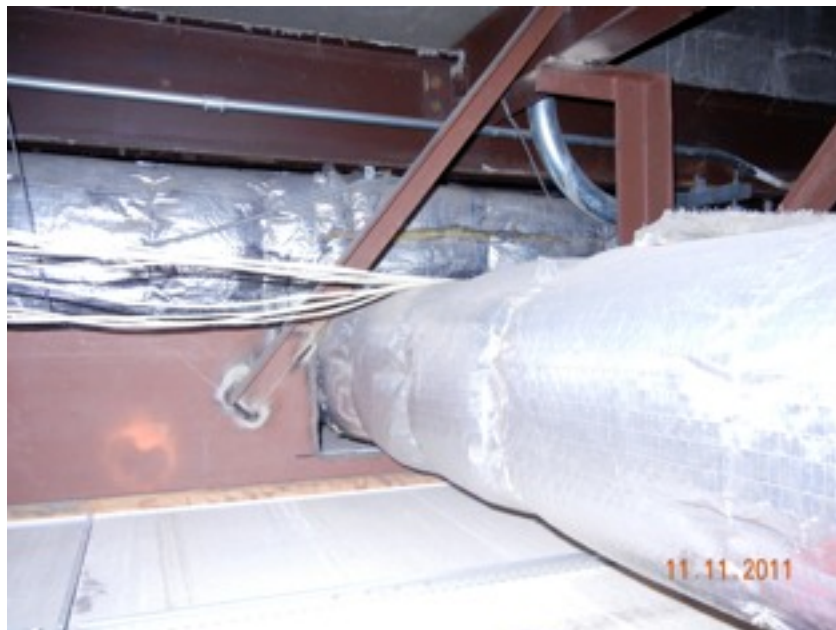
Another view of the cut steel hangers.

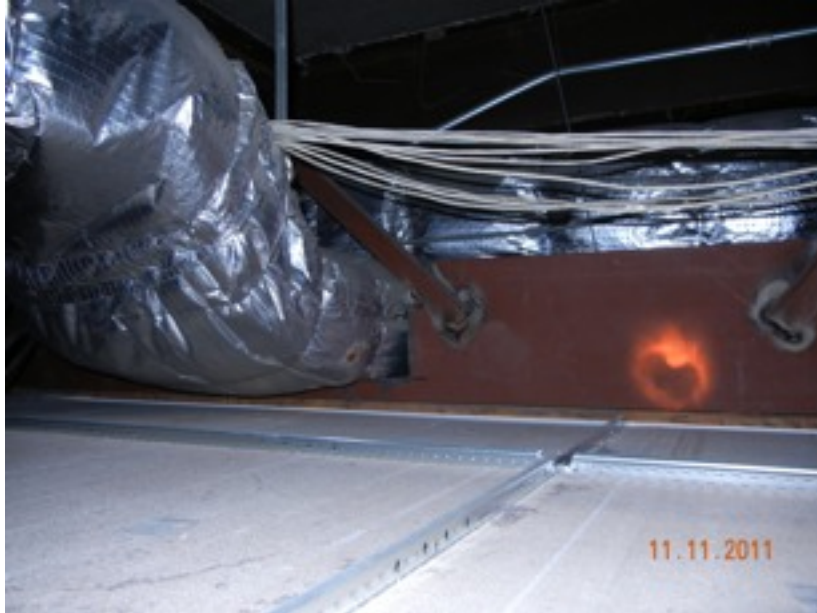
Another view of cut steel meant to support the movable partition below.

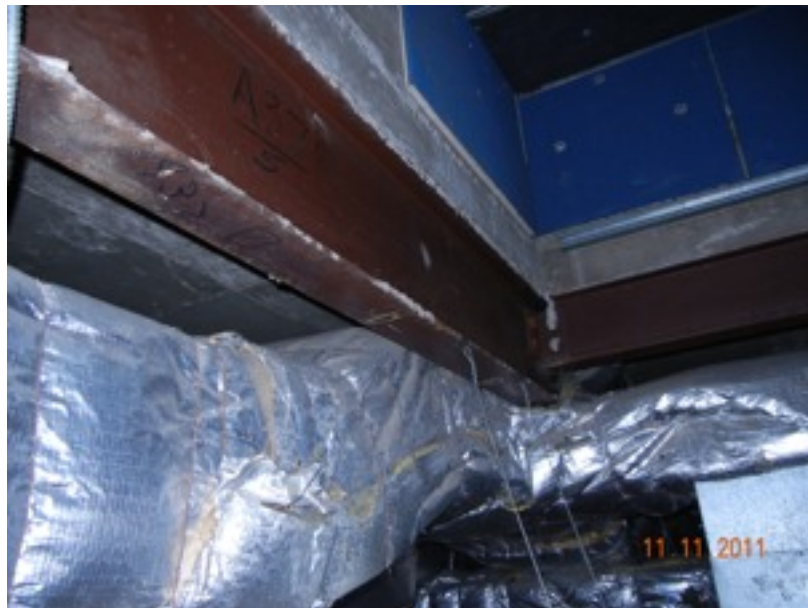
View of a steel framework that supports the roof top HVAC equipment. There are signs of minor water intrusion. The seals and flashing should be reviewed.
