## CONSULTING ENGINEER, P.C.

January 31, 2012

Re: Structural Condition Survey at  
Mastic Moriches Shirley Community Library  
Shirley, NY

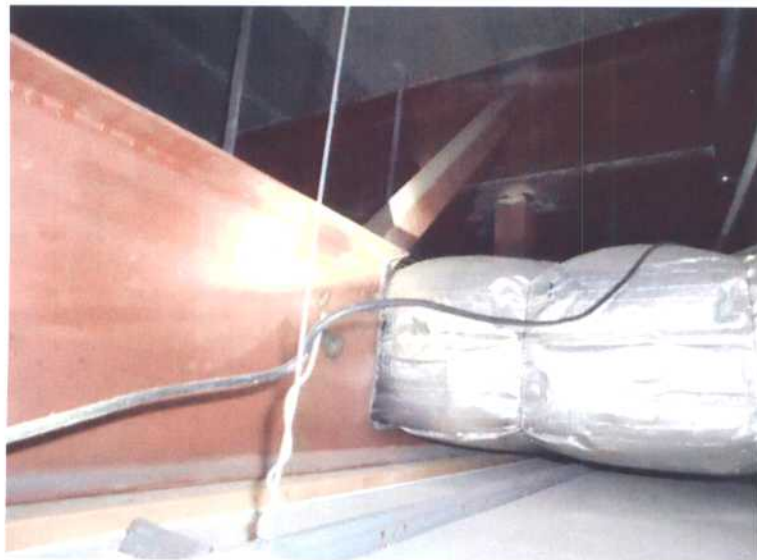
2. Folding Partition Support Beam:

The steel beam originally designed to support the folding partition adjacent to the circulation desk has been cut at two locations to install ductwork in the ceiling. It appears that angles were added at the time to re-support the beam at either end of the notch. Based on our conversation with library personal, the folding partition is currently inactive and has been for many years. Since the beam is currently unloaded, the notch is not a serious structural concern at this time. However, if it is the intention of the library to use this door in the future, a full structural analysis of the beam will be have to be done and additional supports and/or strengthening of the beam may be required.

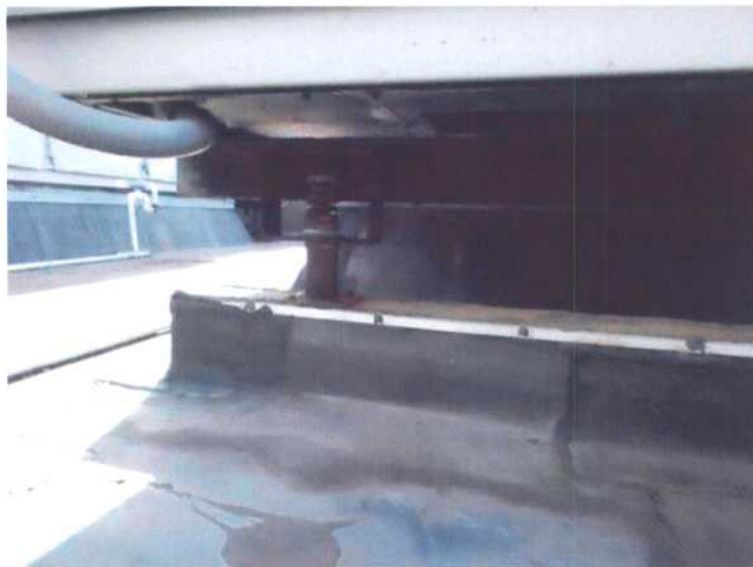
4. Roof Dunnage:

The existing steel roof dunnage supporting the roof top mechanical units for the addition are showing signs of rust and decay. This is especially evident for the isolation springs, where severe rusting was observed. The steel dunnage beams will have to be cleaned and repainted and the springs may have to be replaced in the near future.

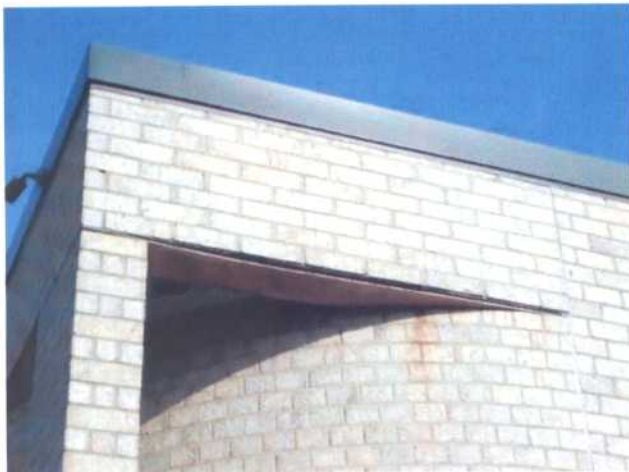
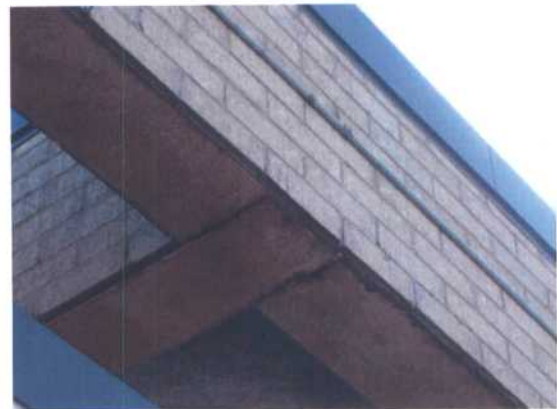
#### 1. Lintel Beams:

A few of the existing steel lintel beams in the original building are severely rusted and in need of immediate repair. Specifically, the beams occur at the southwest and southeast corners of the building and at the front entrance. At each location, water appears to be penetrating the brick and has rusted the bottom plate of the lintel. The rusting has become so severe that the plate has separated from the support beam above.

This condition must be repaired as soon as possible to avoid further damage to both the steel lintel and the masonry wall. Although the repair will vary depending on a full analysis of the condition, it will likely consist of removing a portion of the brick wall, cleaning the rust from the steel beam and plate and reconnecting the lintel plate. If the rust has begun to delaminate the steel, replacement of the plate may be necessary.

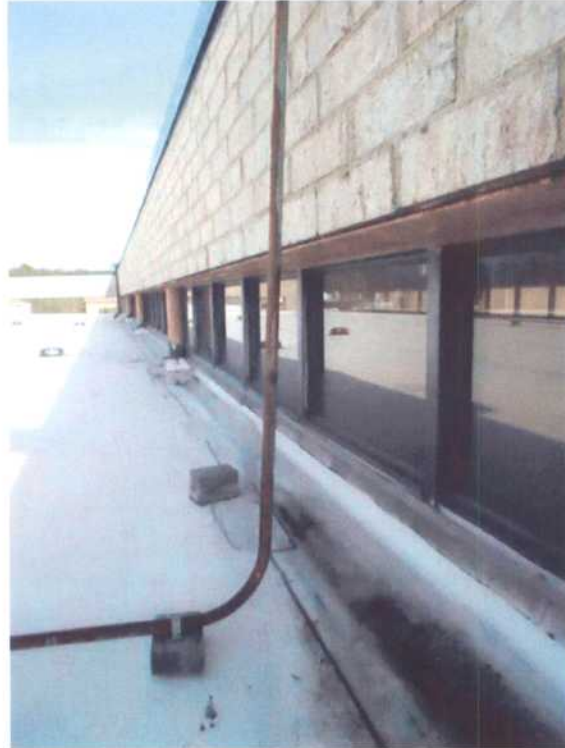
#### 2. Exposed Steel at Clearstory:

The exposed steel columns and lintels at the clearstory area of the original building are showing the beginning signs of rusting. We observed surface rust on both the

columns and lintel plate along the clearstory wall on both sides of the library. Although this condition is not critical at this time, the steel should be cleaned and painted in the near future to prevent further damage.

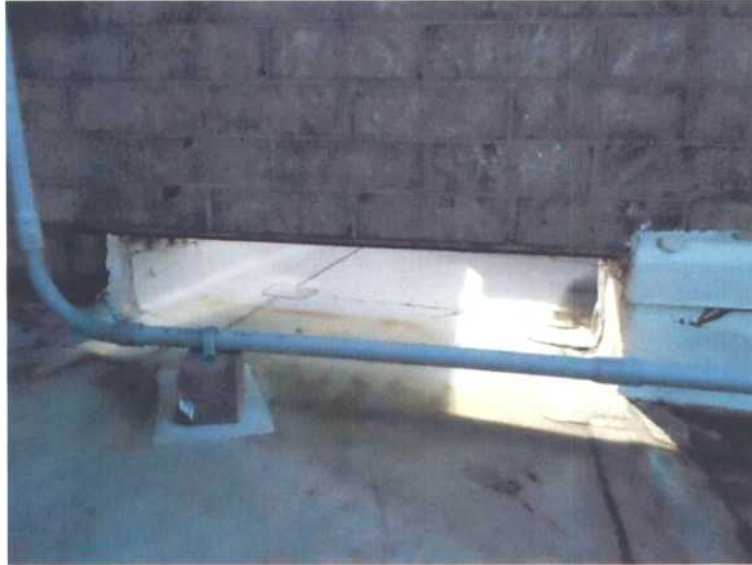
### 3. Lintels at Roof:

We observed a few loose lintels on the roof at the front (west side) of the original building that are rusted and in need of repair. These lintels occur in the masonry walls which extend above the roof and appear to have been installed to facilitate drainage of separate portions of the roof. Although the rusting varies in severity, it mostly appears to be surface rust and can be repaired by cleaning and repainting.
