**AN EXISTING ARCHITECTURAL CONDITIONS SURVEY REPORT FOR THE  
MASTIC MORICHES SHIRLEY COMMUNITY LIBRARY  
407 WILLIAM FLOYD PARKWAY  
SHIRLEY, NY 11967**

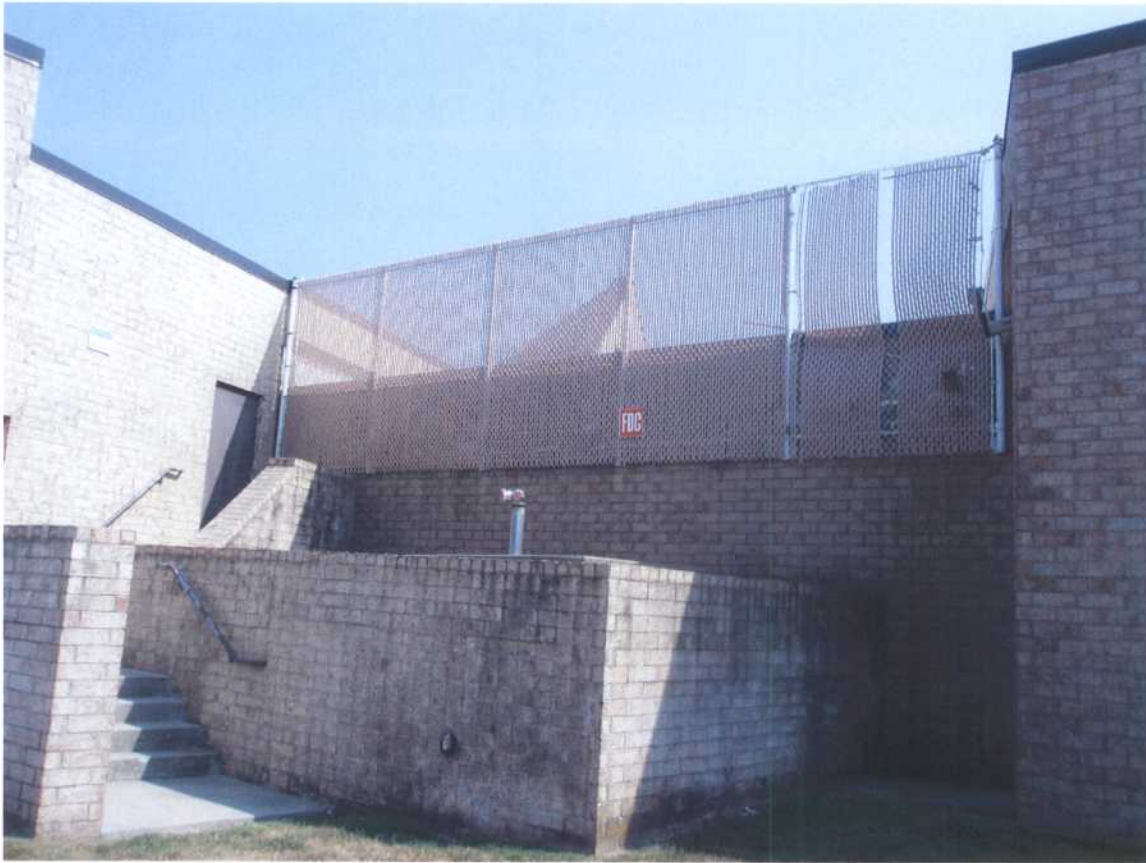
**Photo 'A'**

For the most part the original 1982 and 1995 addition exterior brick veneer looks in good condition. However, the brick was custom made and was used at Hofstra University, hence the name "Hofstra Brick". This only becomes an issue when brick repairs are required. The jointing appears to be sound and weep holes are provided and open in locations where one would expect them to be. It appears that a few areas can use some minor repointing and a power washing to remove mildew (see Photo "A"). This is a common occurrence on the north side of buildings.

Existing brick to receive power washing.

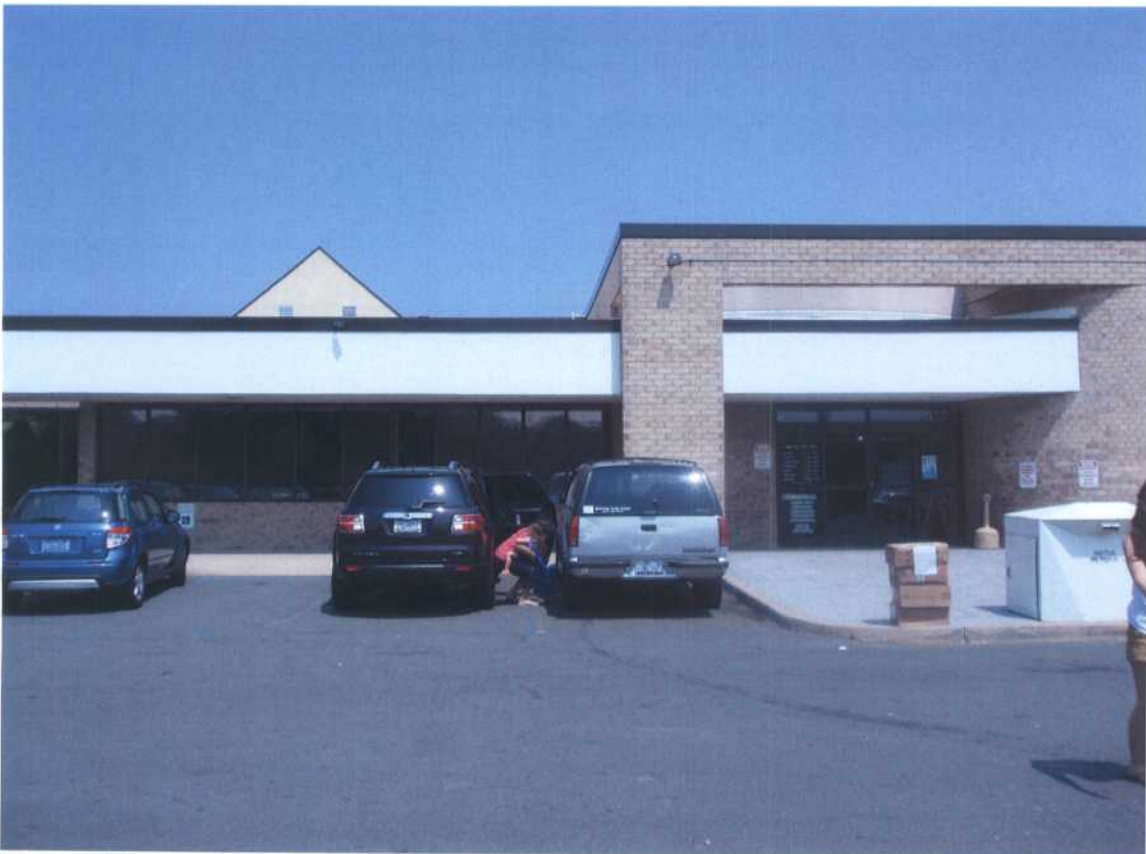
**Photo 'B'**

Cement Fascia and soffit which occur across the front (west) elevation of the building are in good shape and require very little cosmetic patching. The fascia appears to have been cleaned and painted recently whereas the soffit requires both cleaning and painting in some areas. (See Photo "B")

Existing cement fascia and soffit.

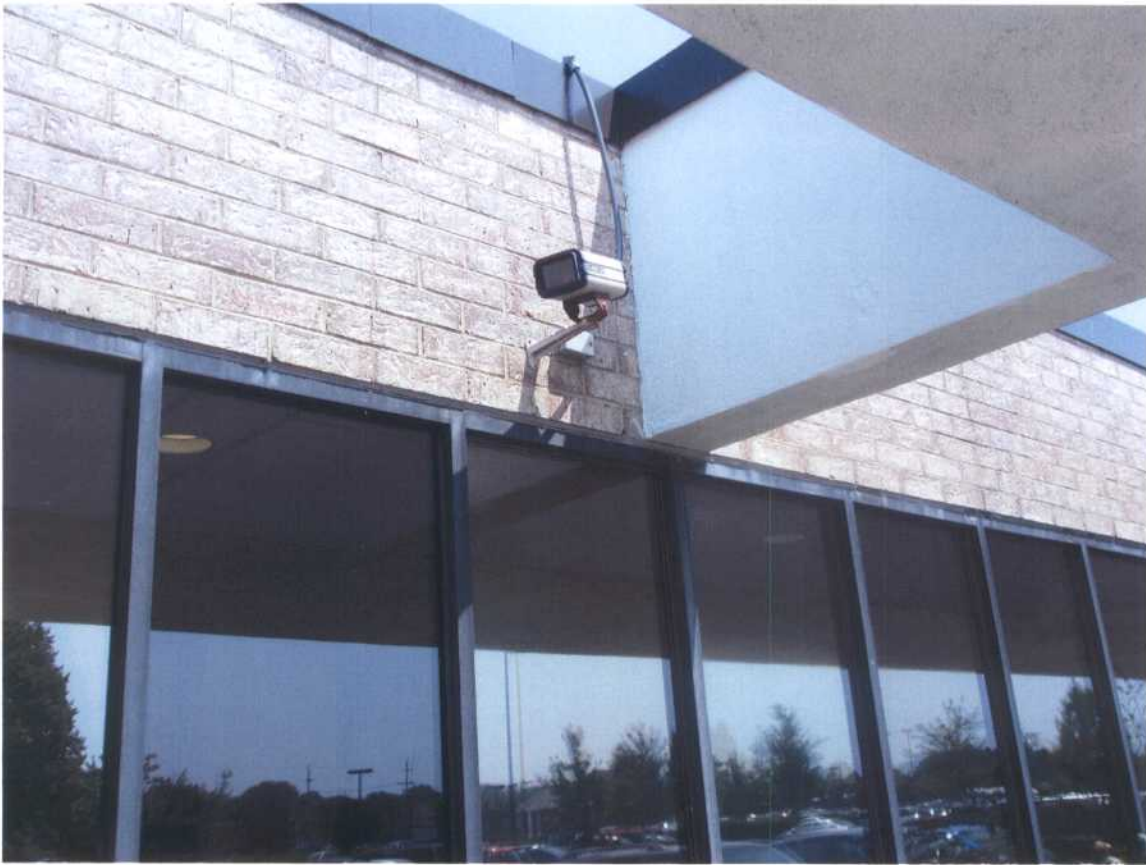
The windows throughout the entire building are insulated glass set in duranodic bronze alum. frames for the most part set flush with exterior brick veneer. The frames appear to be in good condition with occasional pitting in some areas and the insulated glass panes for the most part are in good condition. (See Photo "C") A few of the windows show

leaking in the perimeter seals thus causing the glazing to fog up in between. These panels should be replaced. (Note: It should be noted that although these windows and caulking appear to be in good condition, they are 30 years old. They have reached their life expectancy which is why the seals are letting go. At the very least all windows should be recaulked.)

**Photo 'C'**  
Typical exterior windows.

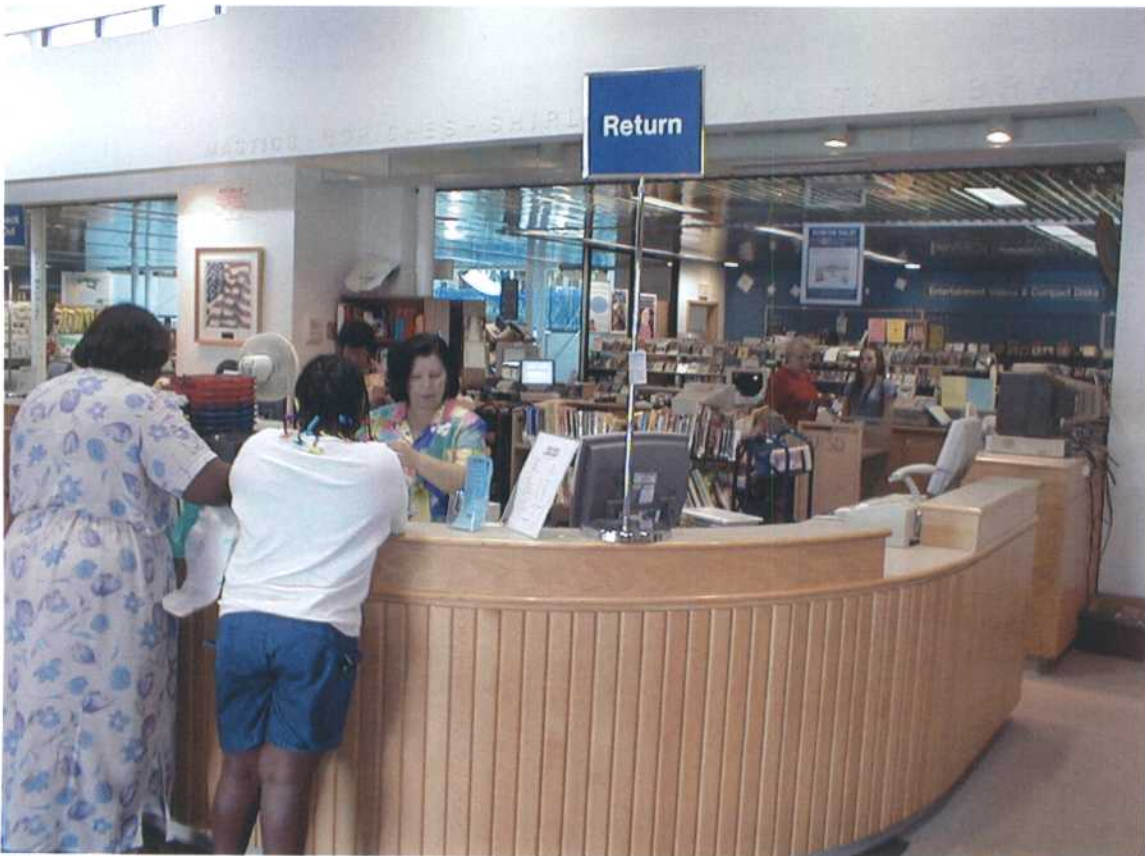
The Circulation and Information Desks are structurally sound but they can use a cleaning and refinishing if not replaced with new ones that would incorporate a better layout at the same time facilitate the running of computer cables and wiring. (See Photo "D")

**Photo 'D'**  
Existing circulation desk.

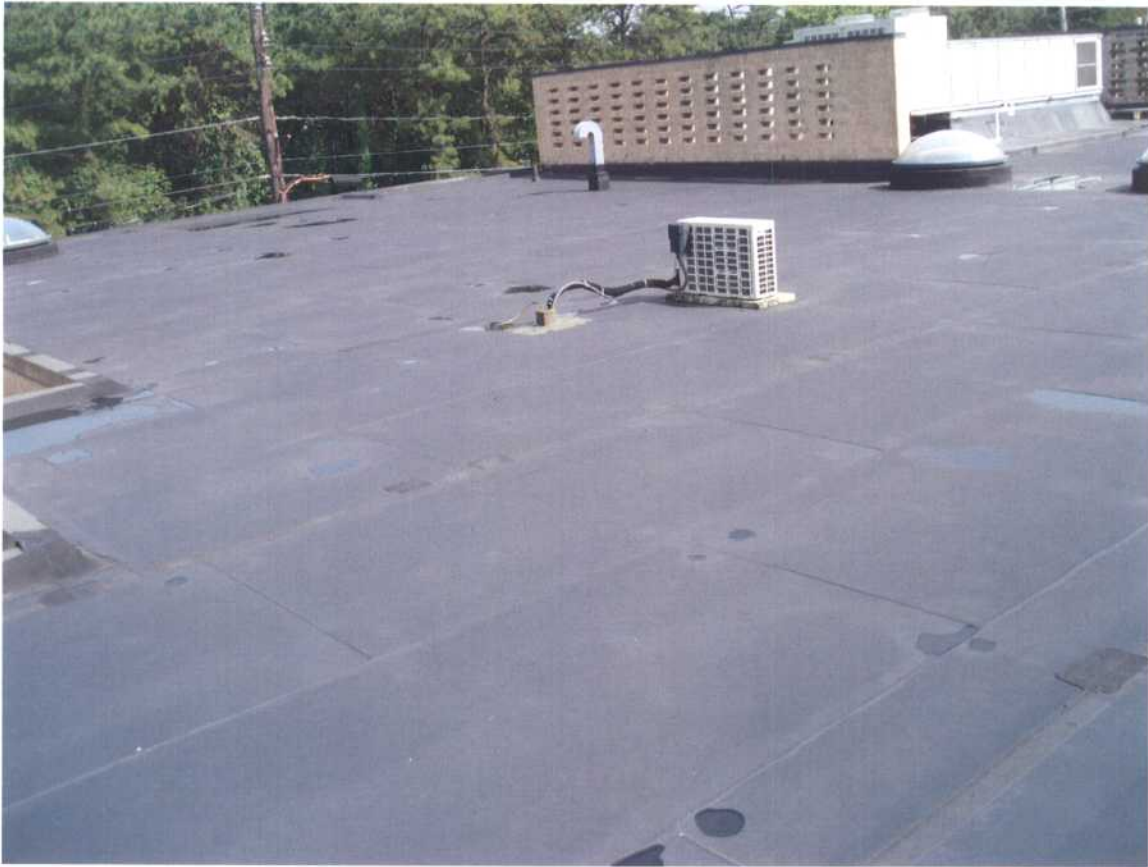
The original 1982 roof was replaced in 2009 with white rubber membrane and has performed well since that time. The 1995 roof is 17 years old and is comprised of a black rubber membrane. ("See Note E".) Some flashing work had been done around the existing large skylight during the 2009 roof replacement and that appears to have stopped the leaks. There are six individual smaller skylights that will need to be replaced in the near future. ("See Note F".)

**Photo 'E'**  
1995 –Roof area

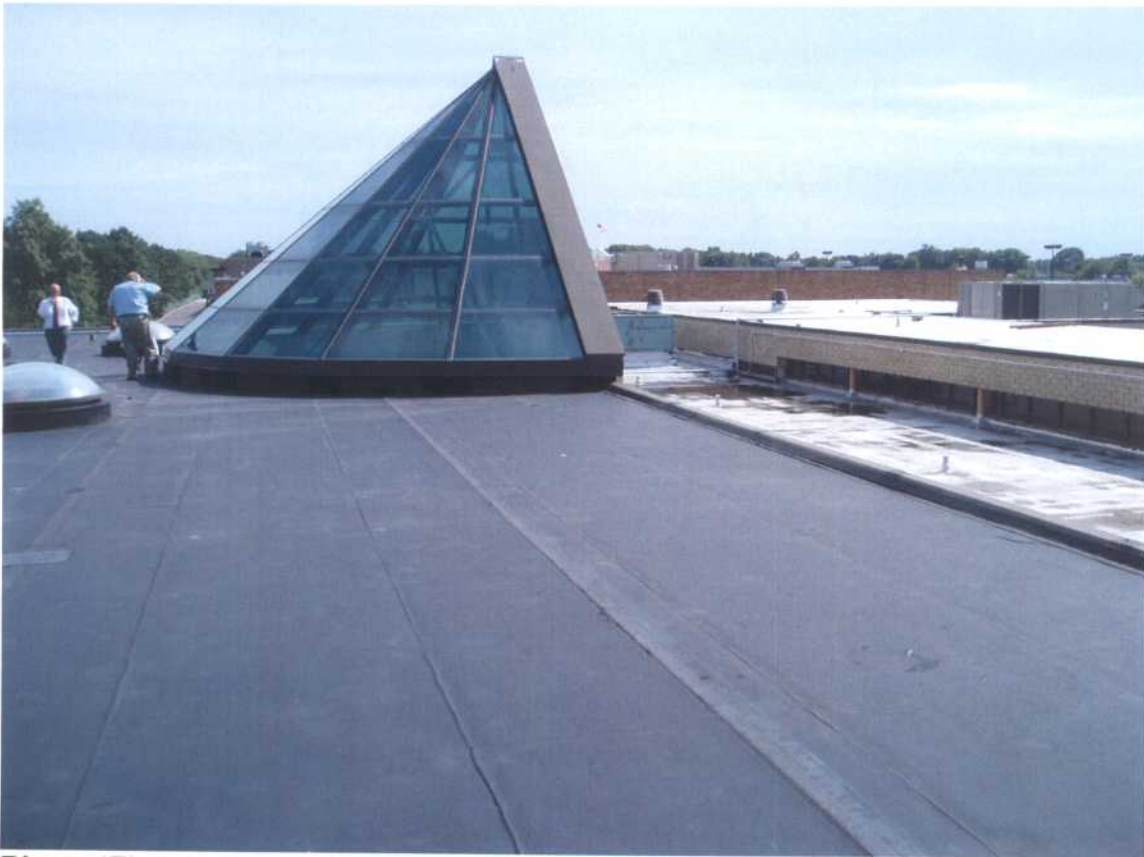
**Photo 'F'**  
1995 –Addition roof skylight

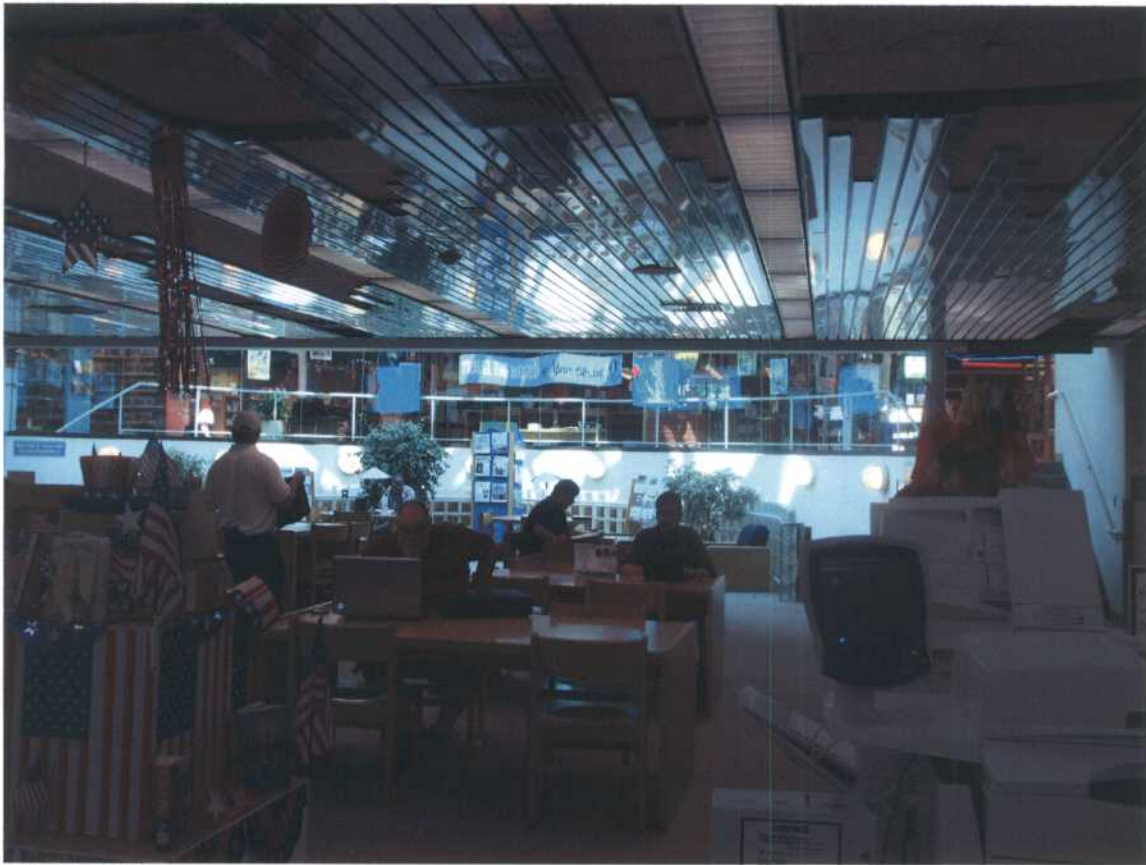
The gyp board ceilings are in good condition and require minor spackling in some areas and the entire gyp. board painted. The 2 x 4 lay-in and the 4" wide chrome panel systems are all due to be removed and replaced, especially the chrome panel systems since a number of locations are missing parts. It should also be noted that these existing panel ceilings give off a large amount of reflection and glare and are not good for reading. (See Photo "G")

**Photo 'G'**  
Existing chrome panel suspended ceiling.

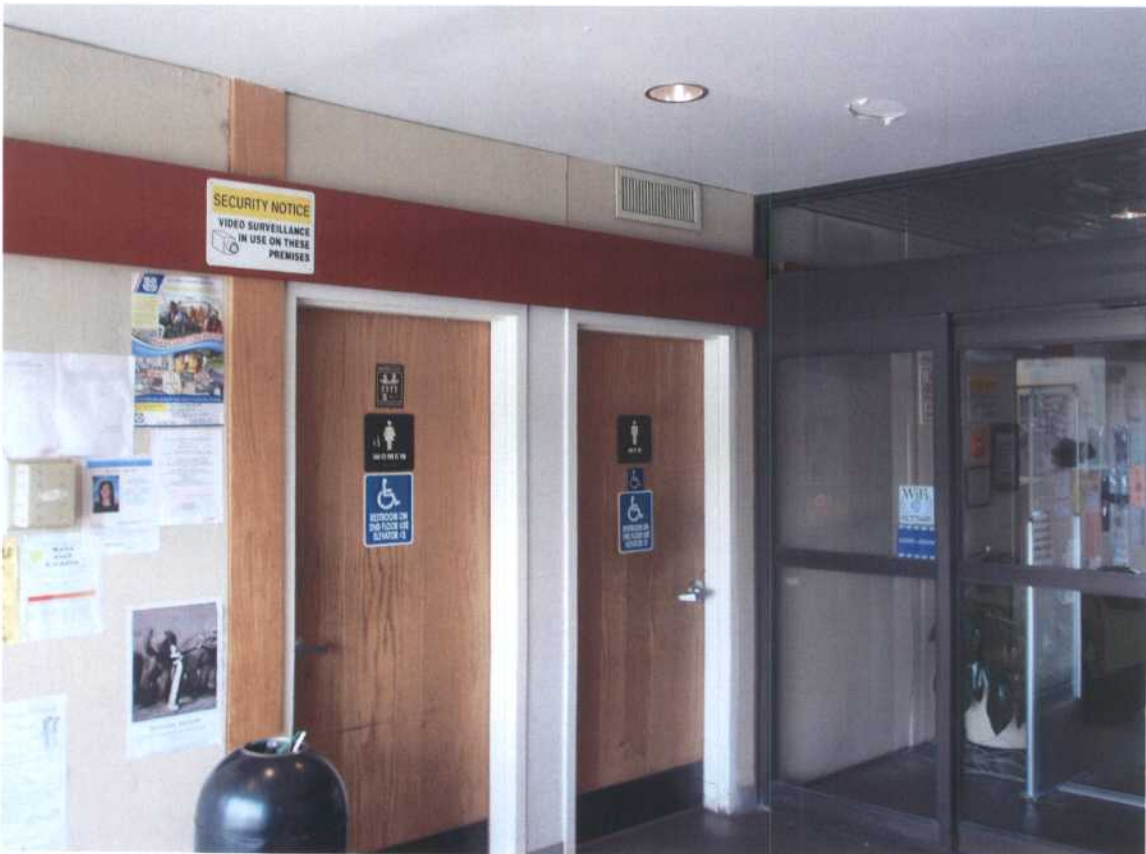
From a Building Code point of view the existing toilet facilities appear to meet the minimum number of fixtures and since a few handicapped accessible single use Toilet Rooms had been constructed, they also meet the minimum requirement of the A.D.A. But in reality these existing staff and public toilets are inadequate in both number of fixtures and A.D.A. accessibility and require a complete re-design. The location of the existing public toilets also need to be addressed and possibly moved since they cause both a "cold air" infiltration problem at the Circulation Desk and also a gathering place for unwanted non-library patrons. (See Photo "H")

**Photo 'H'**  
Existing public Men and .Women toilet rooms in poor location and Not ADA Accessible

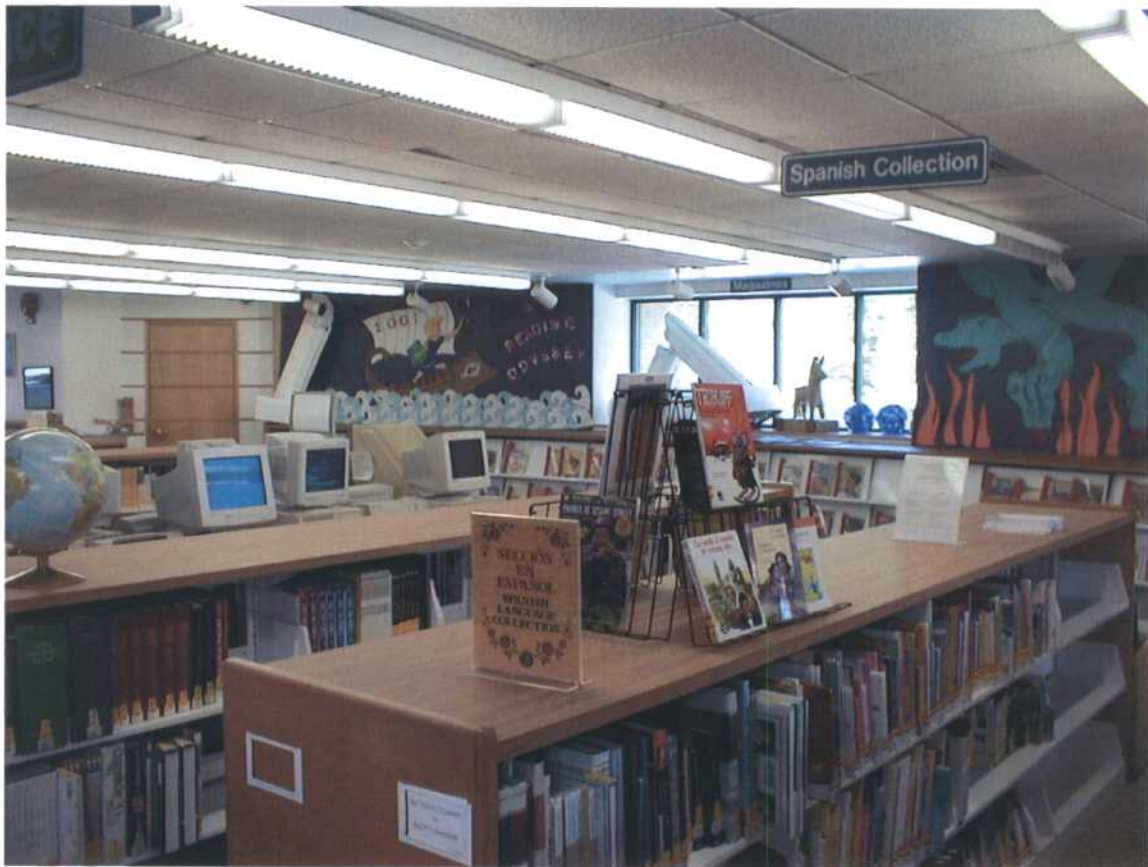
The Lighting levels within the entire facility varies a great deal and are original. All lighting should be replaced when ceilings are replaced. (See Photo "I")

**Photo 'I'**  
Lighting levels.

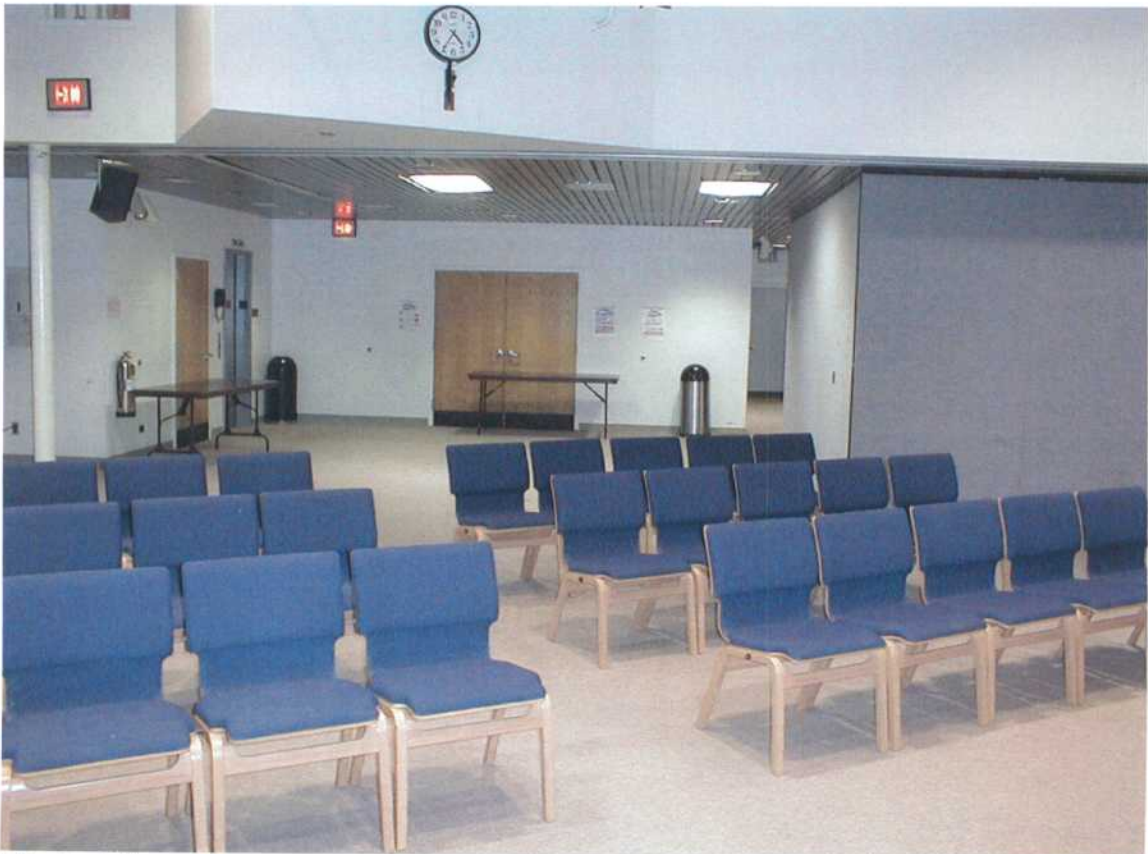
5. The entire lower level Community Room should be reconfigured to allow for a better means of egress when currently divided into individual meeting rooms and the existing elevator now opens into one such room. Lighting, flooring and sound control all should be replaced to bring this area back up to a useful more inviting public meeting area that this Library deserves. In addition to the above we recommend modifications to the existing stage to relieve an unsafe condition would be recommended. (See Photo "J" & "K".)

**Photo 'J'**  
Community Room

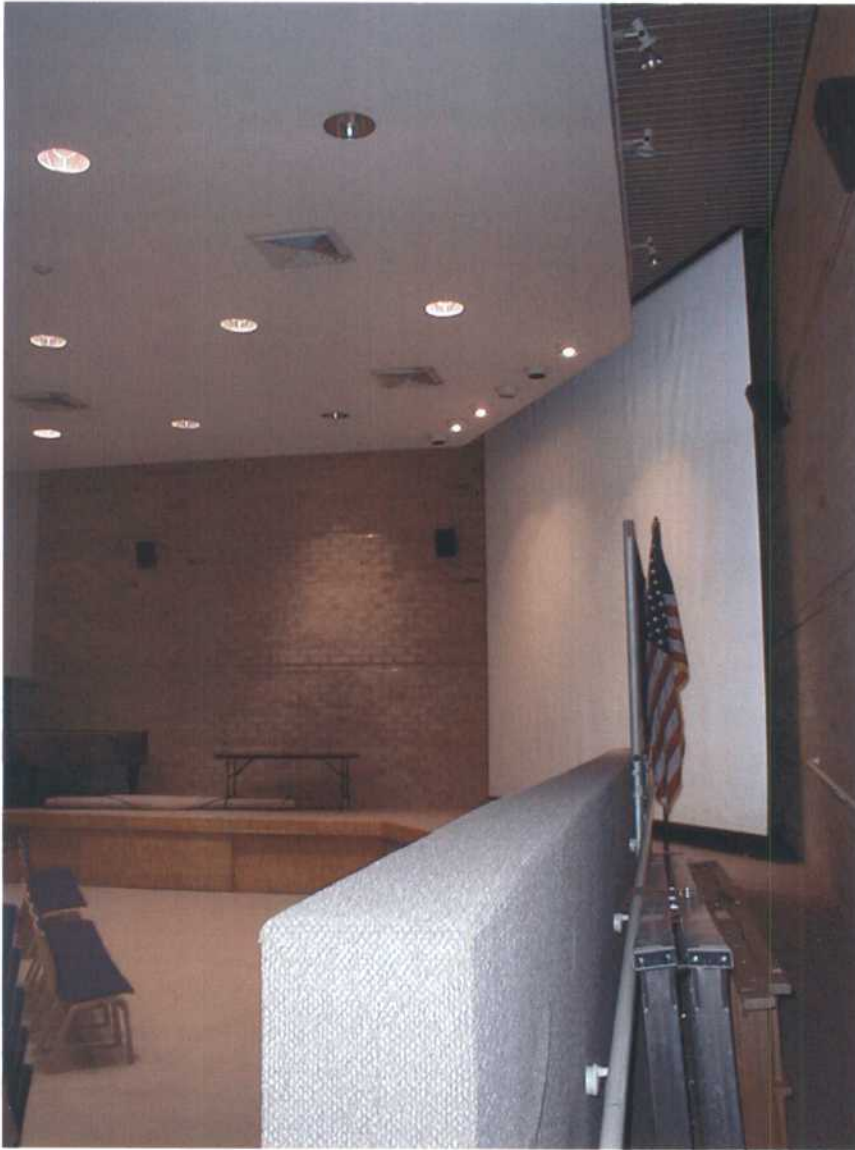
**Photo 'K'**  
Community Room
